Manhole Inspection Summary

Manhole # S33C__005MH

Insp Date: **12/9/08 2:18 PM**

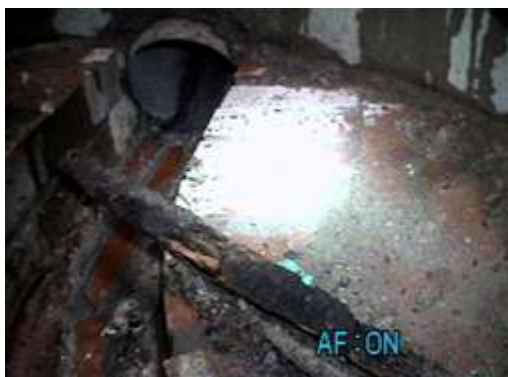
Misc

bench debris

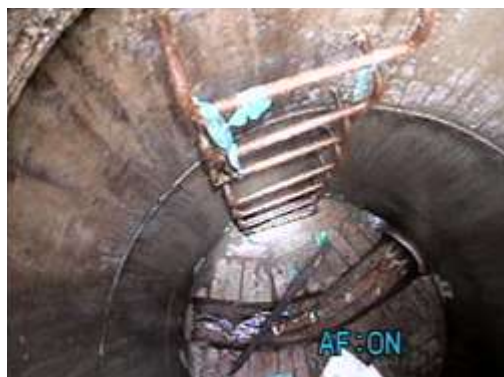
Defect 2

Steps Count: **7** Missing: **0** ☒ Corroded

steps corroded

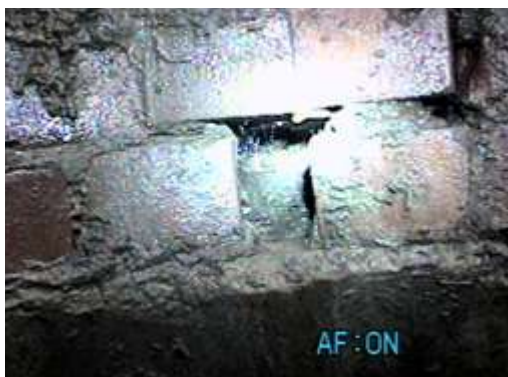
Defect 1

Condition: ☐ Sound ☐ Cracked ☐ Root Intrusion ☒ Loose Brick ☒ Deteriorated

Infiltration: ☐ None ☐ Joint ☐ Cracks ☒ Mortar ☐ Roots ☐ Wall

chimney loose bricks deteriorated, infiltration

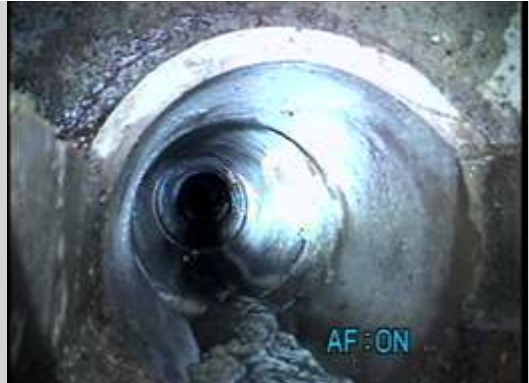
12 O'Clock Outflow

10 in. Circular Gravity Sewer
Pipe Out @ 12 O'Clock

Pipe Material: **Clay** ☐ Pipe Lined

Invert Depth: **10.10** (ft.) Flow Characteristics: **Slow**

Infiltration: **None** Pipe Seal Cond: **Unknown**

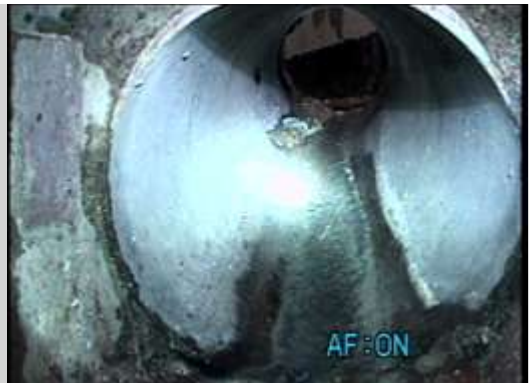
7 O'Clock Inflow

8 in. Circular Gravity Sewer
Pipe In @ 7 O'Clock

Pipe Material: **Clay** ☐ Pipe Lined

Invert Depth: **9.88** (ft.) Flow Characteristics: **Slow**

Infiltration: **None** Pipe Seal Cond: **Unknown**
